# **OPERATING EXPERIENCE WEEKLY SUMMARY**

**Office of Nuclear and Facility Safety**

**October 23 - October 29, 1998**

**Summary 98-43**

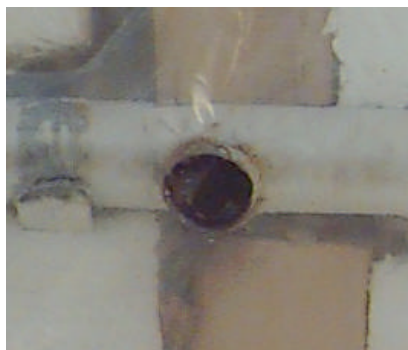
**Figure 1-1. Damaged Conduit**

Investigators determined that the construction subcontractor drilled through one layer of the masonry block wall from the interior then inspected it for any interference before he continued to drill. After he successfully drilled through the block wall, he tried to penetrate the exterior metal siding and was unable to. He then performed a visual inspection, identified metal, and assumed that the metal was the exterior siding. The subcontractor drilled a pilot hole from the building exterior, performed another visual inspection, and identified the damaged conduit. Facility personnel performed a zero-energy check, removed the siding, and checked the electrical distribution panel. They determined that the siren circuit breaker had tripped when the drill penetrated the conduit. Figure 1-1 shows an enlarged view of the damaged siren conduit on the building exterior after facility personnel removed the siding. Figure 1-2 shows the damaged siren conduit and conduit that was present on the outside of the siding. Figure 1-3 shows the interior block wall drilling location.

Investigators determined that facility personnel had reviewed facility drawings before beginning work, but that the siren conduit was not identified on any drawings. They determined that the work plan required facility personnel to perform a subsurface investigation to ensure that no cables existed or for workers to use a drill-stop as a safety precaution. They also determined that no one had performed a subsurface investigation because the metal siding would have invalidated the results. However, the construction subcontractor failed to use the required drill-stop. Investigators determined that facility operations personnel authorized the construction subcontractor to begin work, but that no one considered removing the siding to determine if any cables were present beneath it even though conduit was visible on both sides of the wall. Investigators determined that the facility evacuation system was not compromised because siren coverage continued to be provided by other area sirens.
